Saxkøbing Toldbod, Denmark

Project Name:	Saxkøbing Toldbod, Old Custom Building
Country:	Denmark
Owner:	Holger Kristiansens Eff. A/S International Shipping and Transport, Saxkøbing
Architect:	GFK Architects, Saxkøbing
Vandex Applicator:	Saxkøbing Murerfirma ApS, Saxkøbing
Construction Period:	1999

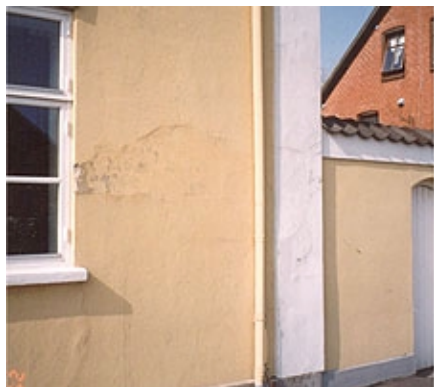
It suffered damage from rising damp and salt attacks.

In the past, it has been flooded by seawater a few times, and below the wooden floor there was a lot of salt efflorescence directly on the ground. The plaster had crazed, and exhibited extensive salt efflorescence.

Damaged cracked corner at the front before refurbishment work started

The first step was to stop the rising damp in the brickwork by injecting VANDEX INJECTION MORTAR (VIM). The base of the walls, (35 m²) affected by salt efflorescence were treated with VANDEX ROUGH CAST and VANDEX ANTISULPHATE.

The rest of the building was also treated with VANDEX ROUGH CAST and finally plastered with VANDEX REFURBISHMENT PLASTER white. Deteriorated areas at the corners and at the entrance were reconstructed with VANDEX REFURBISHMENT PLASTER white.

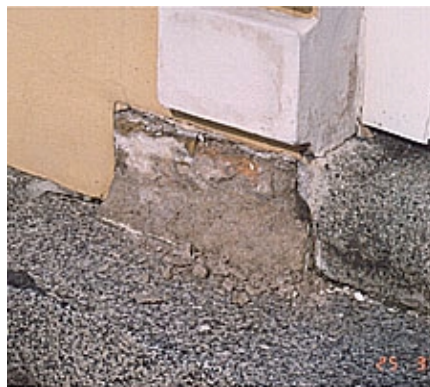
Damaged render left to the entrance before refurbishment work started

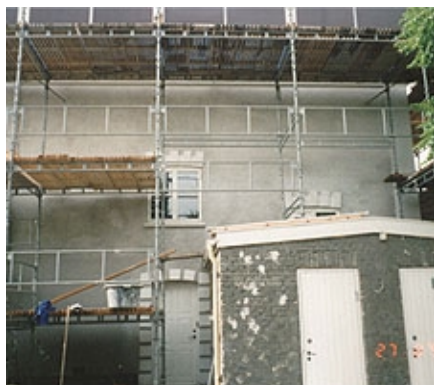
Right side of the building treated with VANDEX REFURBISHMENT PLASTER white as finish before painted

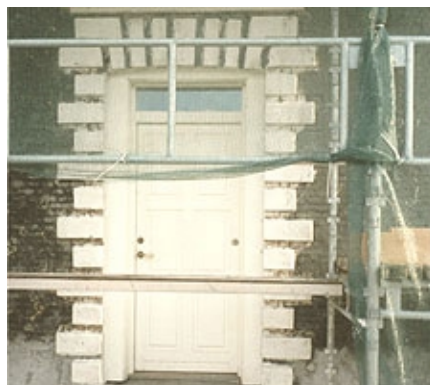
Entrance, lower part treated with VANDEX BB 75 and upper part with VANDEX ROUGH CAST

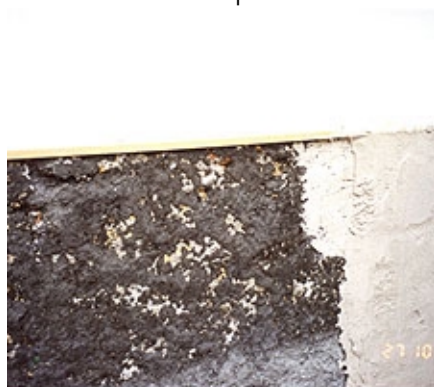
VANDEX ROUGH CAST on the left and VANDEX REFURBISHMENT PLASTER white on the right
